REPORT OF UNDERGROUND COAL MINE INVESTIGATION
FATAL ROOF FALL ACCIDENT

Somerset Mine (I.D. No. 05-00294)
United States Steel Corporation
Somerset, Gunnison County, Colorado

December 18, 1976 ✓

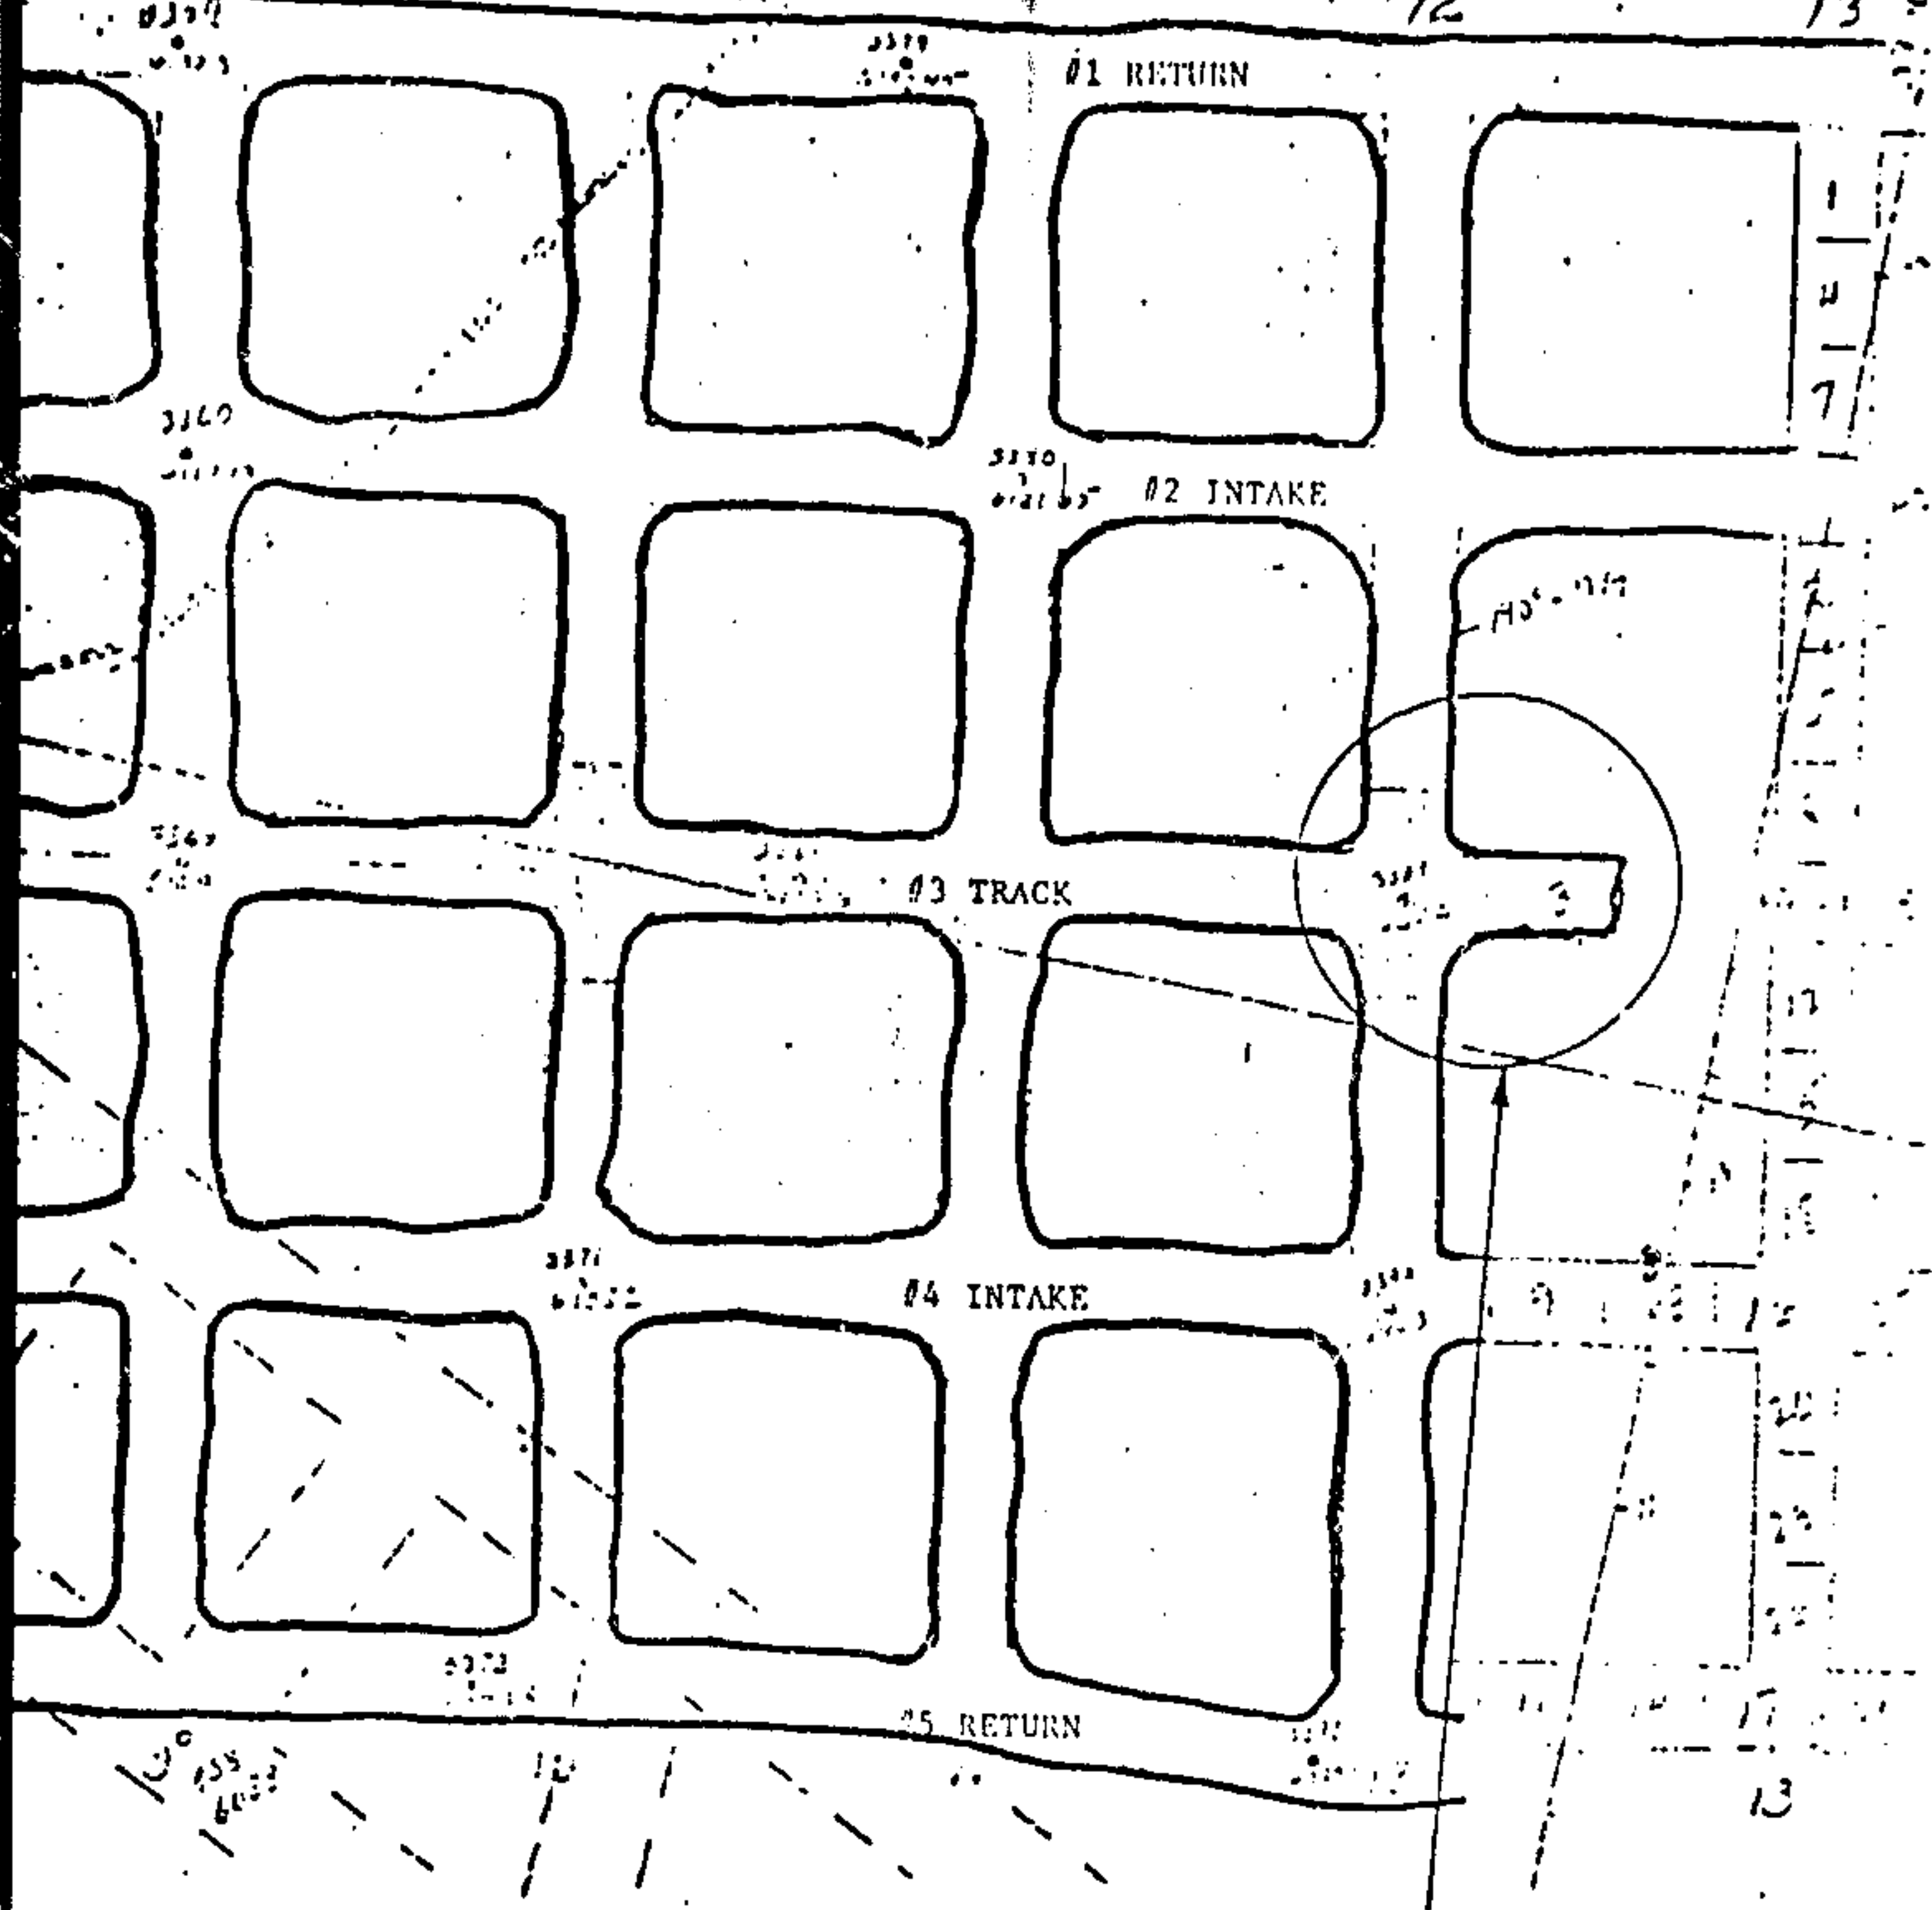
Location of
Coal Mine Roof Fall Accident

On Saturday, December 18, 1976, at about 2:30 p.m., a roof fall accident occurred at the face of No. 3 entry, C seam 1 left section of U.S. Steel's Somerset Mine resulting in the death of Dwight D. McCay, roof bolter helper. McCay had 27 months mining experience, the last five weeks of which were with U.S. Steel, classed as a laborer unskilled. The accident occurred when a bounce threw the two roof bolters into the unbolted area. A kettle bottom measuring 6' by 6' and 36" thick at the apex fell striking McCay. The Fletcher roof bolter was not provided with overhead protection to protect the drill operator while drilling. A temporary roof support (a TRS) system had been removed prior to the accident.

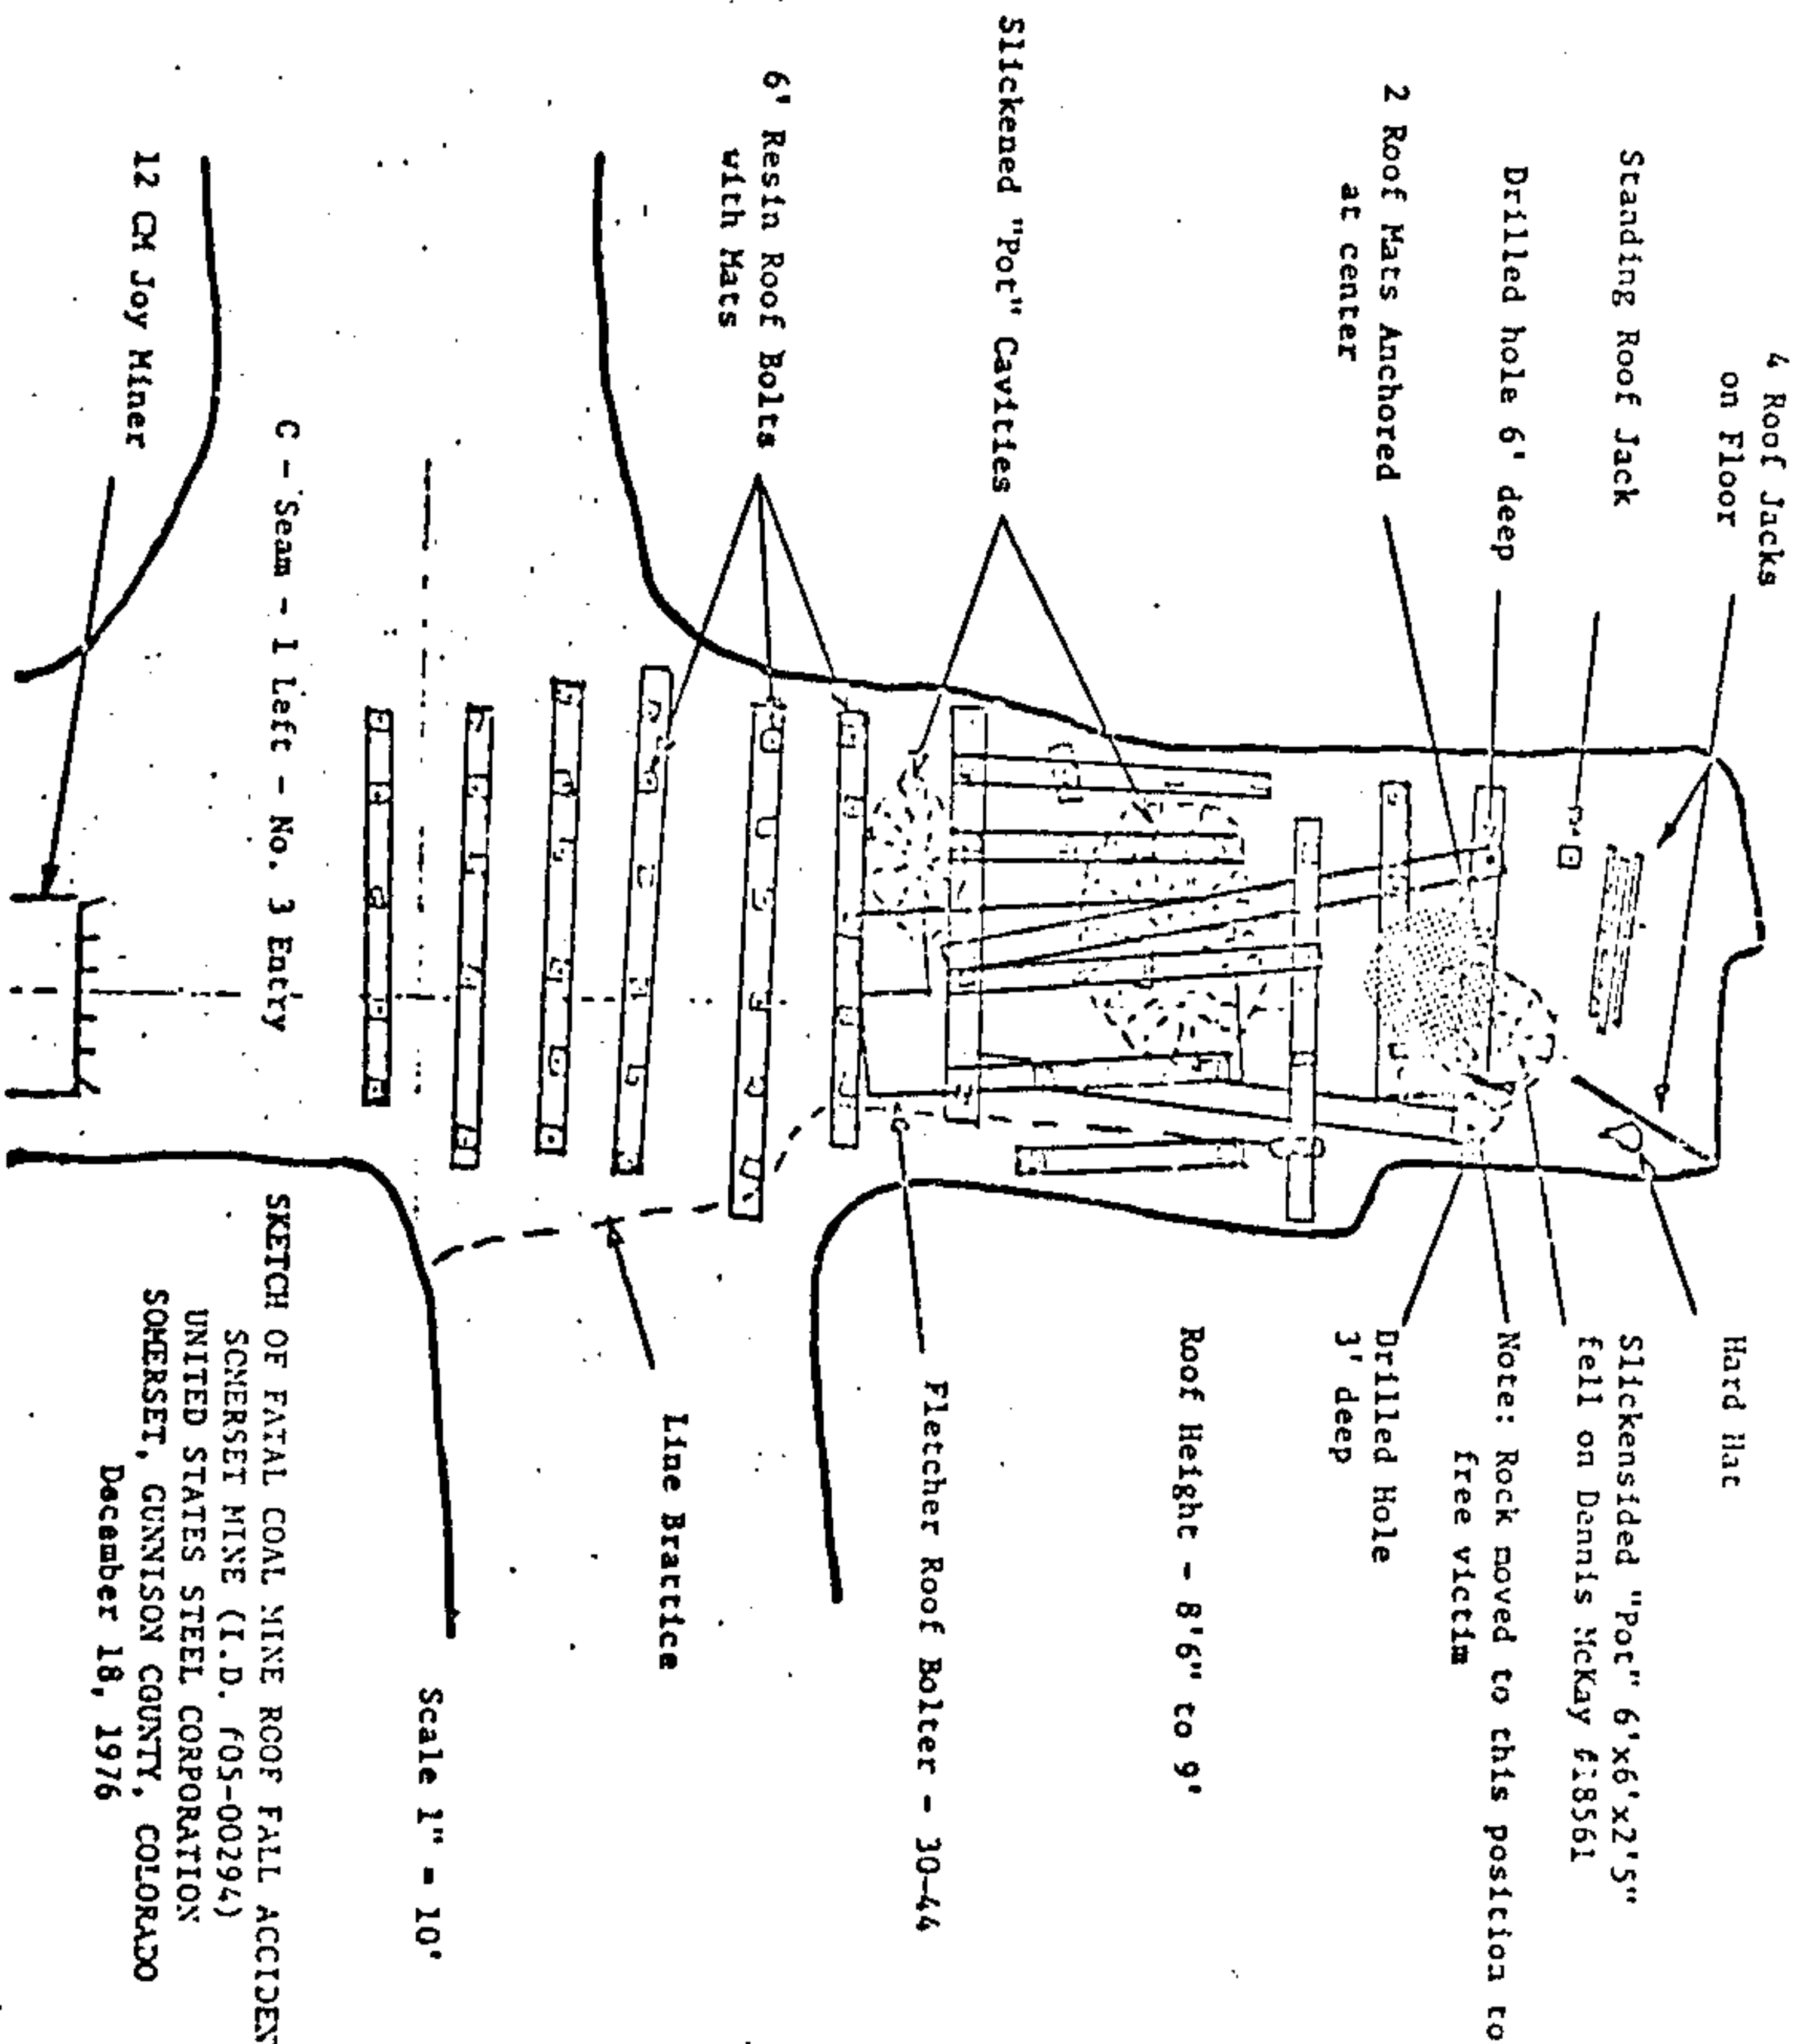
SKETCH OF FATAL COAL MINE ROOF FALL ACCIDENT
 SOMERSET MINE (I.D. #05-00294)
 UNITED STATES STEEL CORPORATION
 SOMERSET, GUNNISON COUNTY, COLORADO
 December 18, 1976

After the lunch period the roof bolting crew took the Fletcher roof bolter from the No. 2 entry to the No. 3 entry and started installing resin type roof bolts. Five safety jacks had been set in the No. 3 entry by the miner crew when the area had been mined on the previous coal producing shift. Five bolts 6' in length had been installed securing one row of roof mats to the top. The center row in the next row of roof mats was drilled and a roof bolt installed to hold the mats in place. Knowles had completed drilling the center hole in the left roof mat and the victim was drilling the end hole in the right roof mat. At this time a bump occurred throwing both men into the face area. Four of the five temporary roof support jacks were dislodged. Knowles stated that he quickly got back under the supported roof and that it was very dusty. Knowles could see the silhouette of the victim kneeling and pulling on his lamp cord to retrieve his hard hat. Knowles called and told the victim to stay where he was until the dust settled. The kettle bottom fell at this time striking McCay. The victim was recovered from under the fallen rock about 15 minutes later.

1. Two kettle bottoms had fallen previously near the accident scene.
2. The C seam of the Somerset Coal Mine has a history of kettle bottoms in the roof throughout the mine.
3. The kettle bottoms cannot be detected by the sound or vibration method of roof testing.
4. The temporary roof support system (T.R.S.) had been removed and the machine was being used without a cab or canopy over the drilling controls.
